Case Histories

Hospital, Contractor Discover Long-Term Solution For Grease And Waste Systems

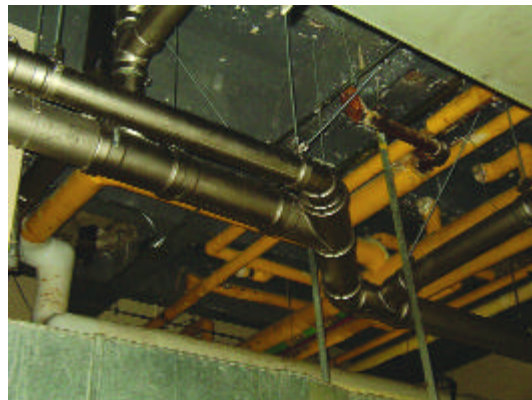
The cast-iron drainage system had been renovated twice since its original installation in 1963, the last time being about five years ago. However, leaks had already begun to develop again, damaging the medical supplies and causing thousands of dollars in ruined and discarded supplies. The hospital facilities staff began to search for a product to install that would prevent these "regular" piping replacements.

The project took approximately five weeks to complete. Greene & Associates had a bit of a learning curve working with the "Push-Fit" piping system, as installation above ground requires thorough bracing at turns and bends to prevent the gasketed joint from moving. Other than that, the company found the stainless-steel system to be a lightweight product that was easy to work with.

The product, manufactured in Denmark, is very well-suited for this type of application. The corrosion-resistant factor of stainless-steel and the smooth surface of the piping material should eliminate much of the problems that the hospital had experienced in the past.
